THROUGH: Chief, Requirements Branch, Reconnaissance Group, CGS
FROM: Chief, CIA/PID (NPIC)
SUBJECT: Soviet Suspect Solid Propellant Test Facilities, USSR
REFERENCE: (a) Requirement C-DDI-3-80,555
(b) CIA/PID Project C 1270-63

SUBJECT: Soviet Suspect Solid Propellant Test
Facilities, USSR

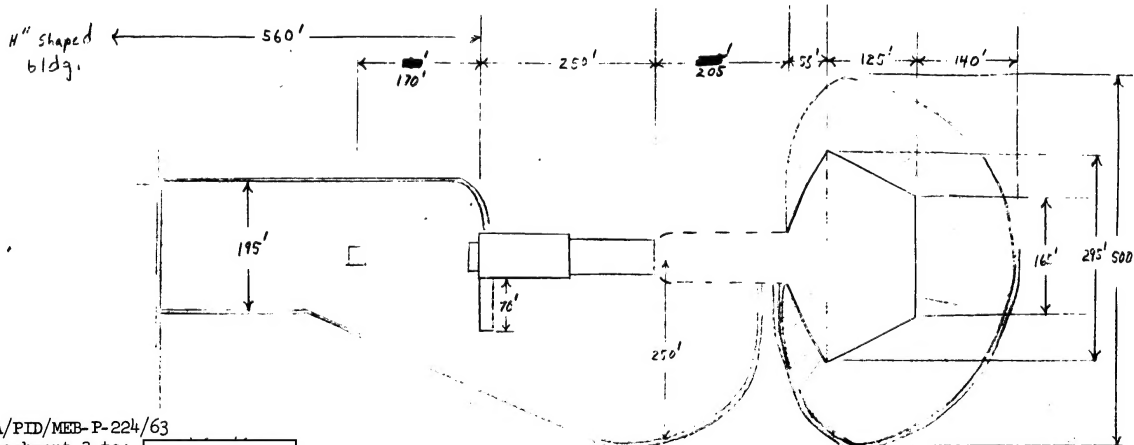
CIA/PID/MEB-P-224/63

(2) The test cell is not revetted or mounded at the Sterlitamak facility and appeared essentially complete in []. The cell is road served at the end which faces a probable bunker/deflector approximately 260 feet away. The road is of a wide turn radius nature. 25X1

(3) The probable bunker/deflector can be observed in []. However, a concrete facing (later its most revealing trait), cannot be observed in [] and cannot be confirmed until []. Though the concrete facing suggests a deflector role, a road serving the rear of the probable bunker/deflector leads to the possibility of an instrumentation role, also. Measurements of the probable bunker/deflector should be considered relatively unreliable due to an extreme distortion of high images. 25X1

A - Probable Test Cell

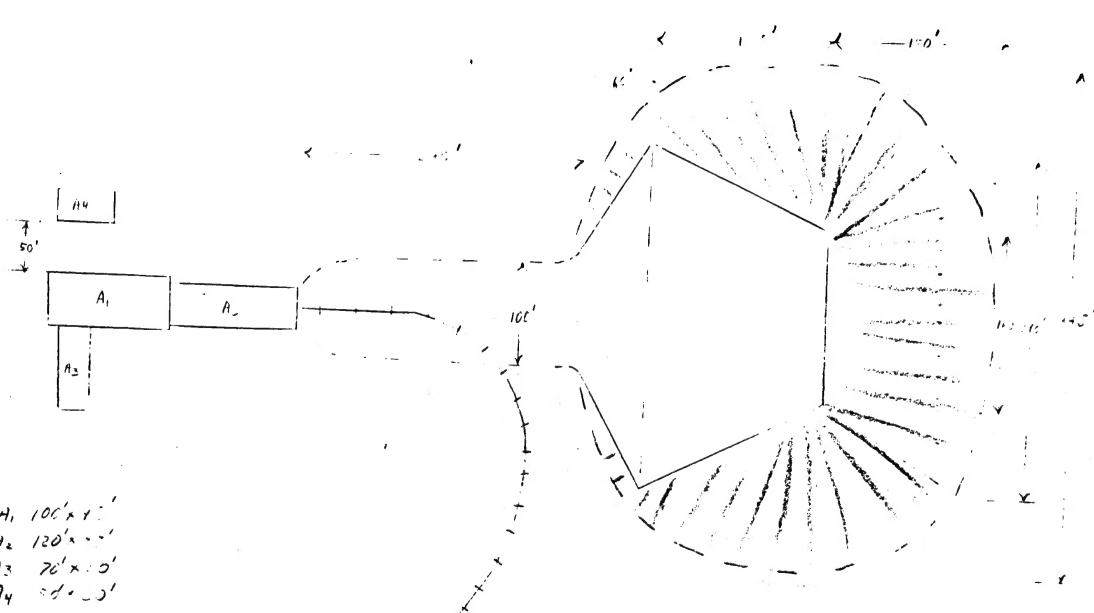
CIA/PID/MEB-P-225/63

c. The test cell at the Perm facility is rail served at the end which is closest to the probable bunker/deflector. The probable bunker/deflector is approximately 250 feet from the end of the test cell.

- A1 100' x 50'
- A2 120' x 50'
- A3 70' x 50'
- A4 50' x 50'

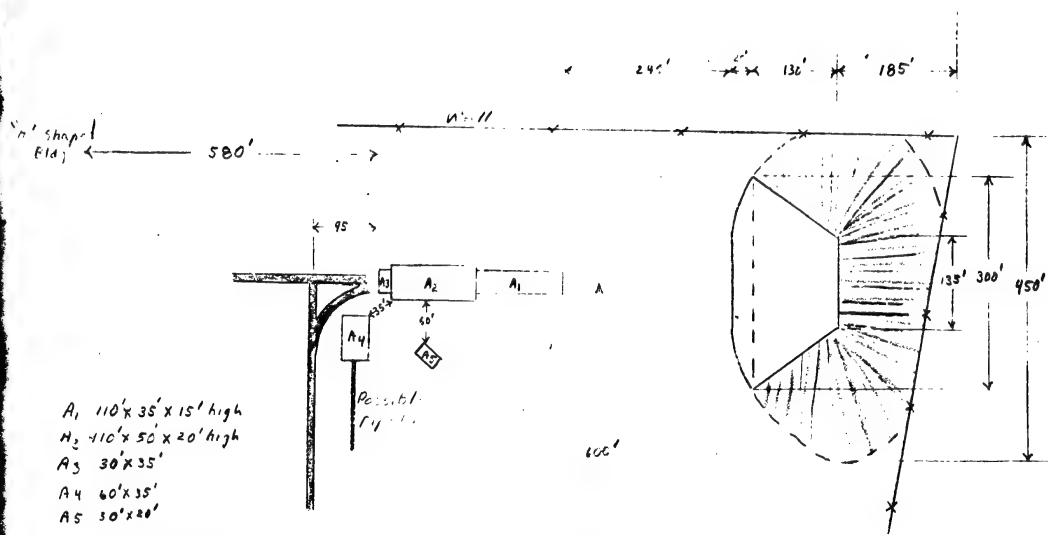
CIA/PID/MEB-P-227/63

(2) The facility has two test cells which are annotated A and B. Test Cell A was first discernible in [redacted] It appeared to be essentially complete at that time. Overhead piping or covered walkways connect Test Cell A to a revetted building approximately 300 feet away. The front edge of the test cell faces a probable bunker/deflector approximately 240 feet away.

(3) Test Cell B, the older of the two cells, appeared essentially complete in [redacted] Cell B is also connected to the same revetted building the Cell A is. Again the connection is made by overhead piping or covered walkways. The front end of Cell B is approximately 75 feet from the 45 feet high probable bunker/deflector which serves it.

(4) The probable bunker/deflector serving Test Cell A is at least 60 feet high. It was first discernible as being under construction in [redacted] However, confirmation of its completion cannot be made until [redacted] when its concrete facing (the most easily identifiable feature at all five suspect facilities) is apparent. The probable bunker/deflector serving Test Cell B was complete (with concrete facing) in [redacted] Though a deflector role is suggested in each case by the concrete facing, no final judgement of this function can be made. There is little or no suggestion that the probable bunker/deflector is served to the rear by any road or trail.

B₁ 100' x 35' x 15' high
B₂ 75' x 25'
B₃ 70' x 25'
Bunker/Deflector 4' high
